NTGA Updates: Asset Management Experiences

The Trouble With Anti-Scalant Systems

The Acid on KA27

NTGA Steamfield Operations

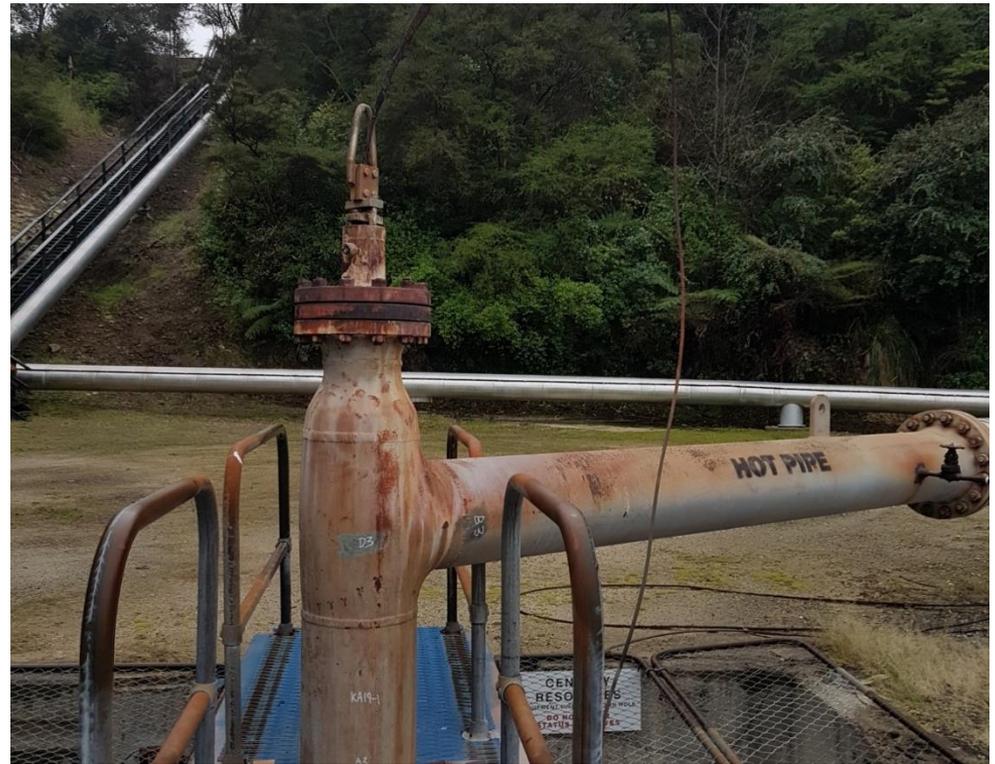
Challenges Upgrading Antiscalant Systems at NTGA

Armoured 1/4" Antiscalant tubing installed into NTGAL Production wells.

Original period between HTCCs' was 20 years with very little requirement for regular PTS testing.

Design required wells to be quenched to remove the dispersion head and close master valve

Increased requirements for reservoir data and asset integrity certainty means minimal quenches.

System redesigned to accommodate regular well testing.

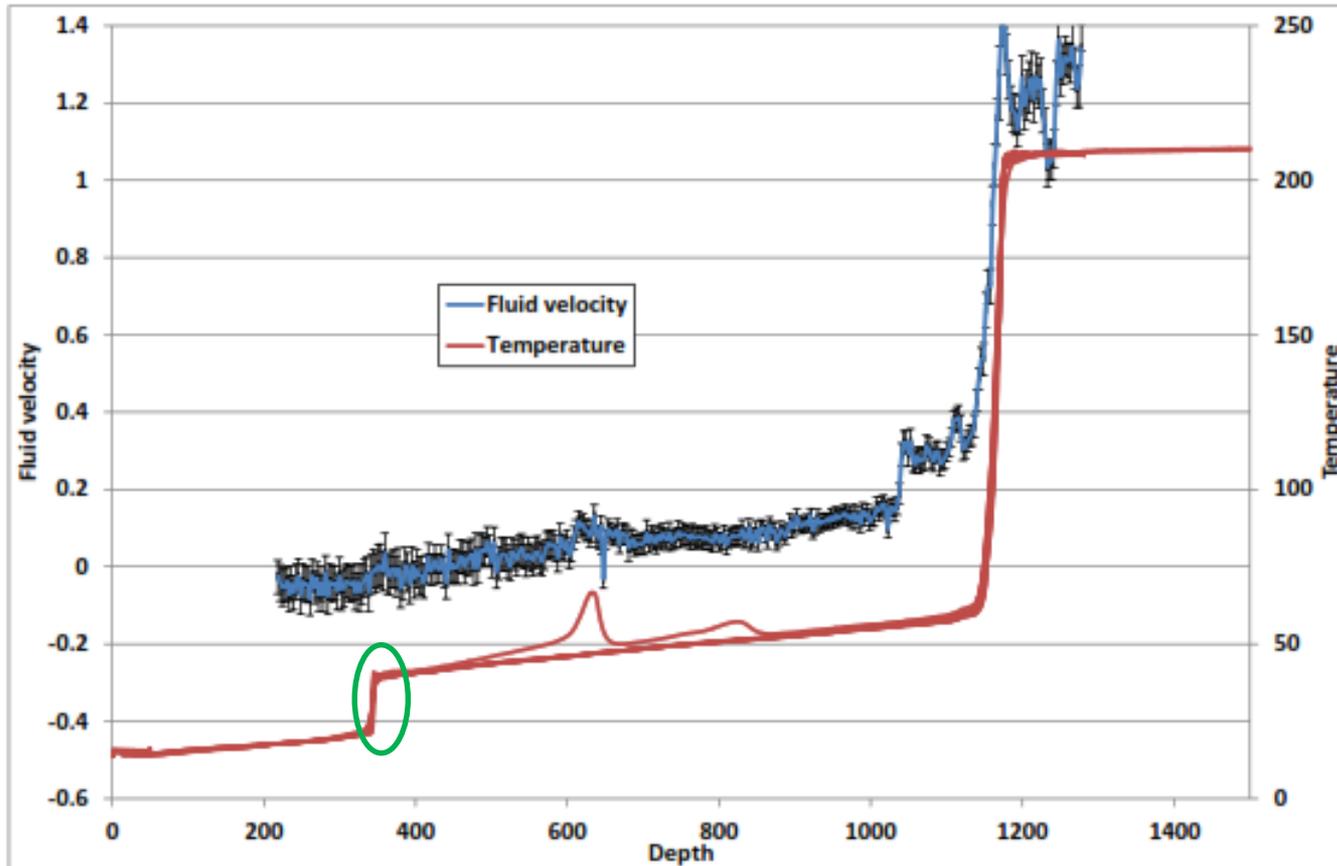
KA47 injection PTS

- Post commissioning, hot fluids permeated the well pad outside of the cellar and 30"/20" annulus
- Chemical analysis determined fluids likely originated from near surface aquifers with ground water mixing
- 2009 annulus was tested for tracers injected into KA38,39 and 40 shallow reinjection wells. +ve returns found, reinforcing shallow aquifers were the cause.
- 2010 Annular cement sealing attempted but unsuccessful.
- Casing annulus gland sealing caps fitted with valves to allow sampling.
- Could not carry out integrity testing because of anti-scalant design and lack of capacity to take well out of service.

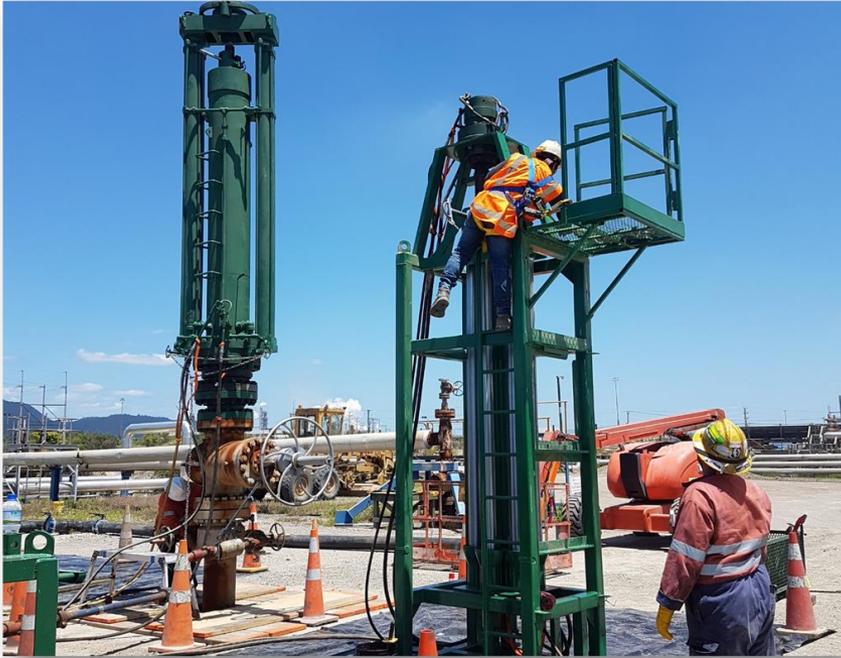
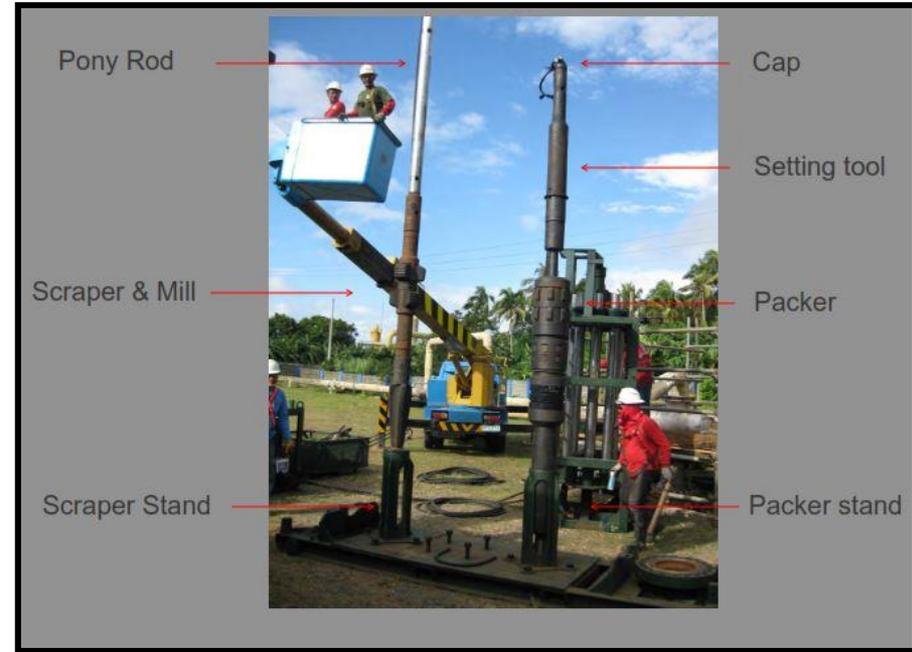
KA47 repair

Packer before insertion into lubricator

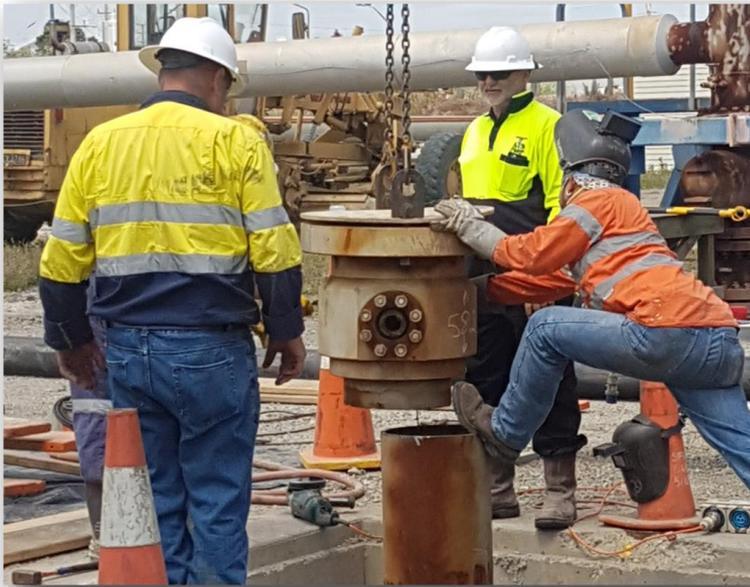
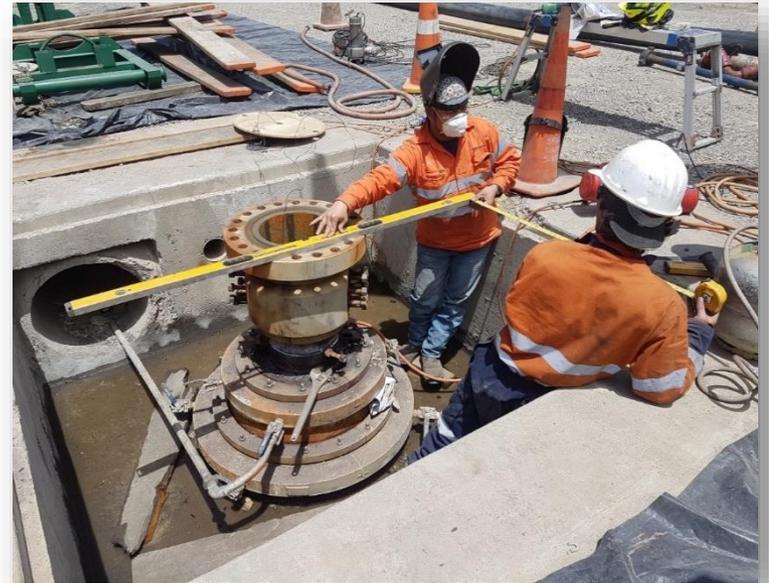
KA47 repair

Adjusting the CHF position for the rig with the packer set

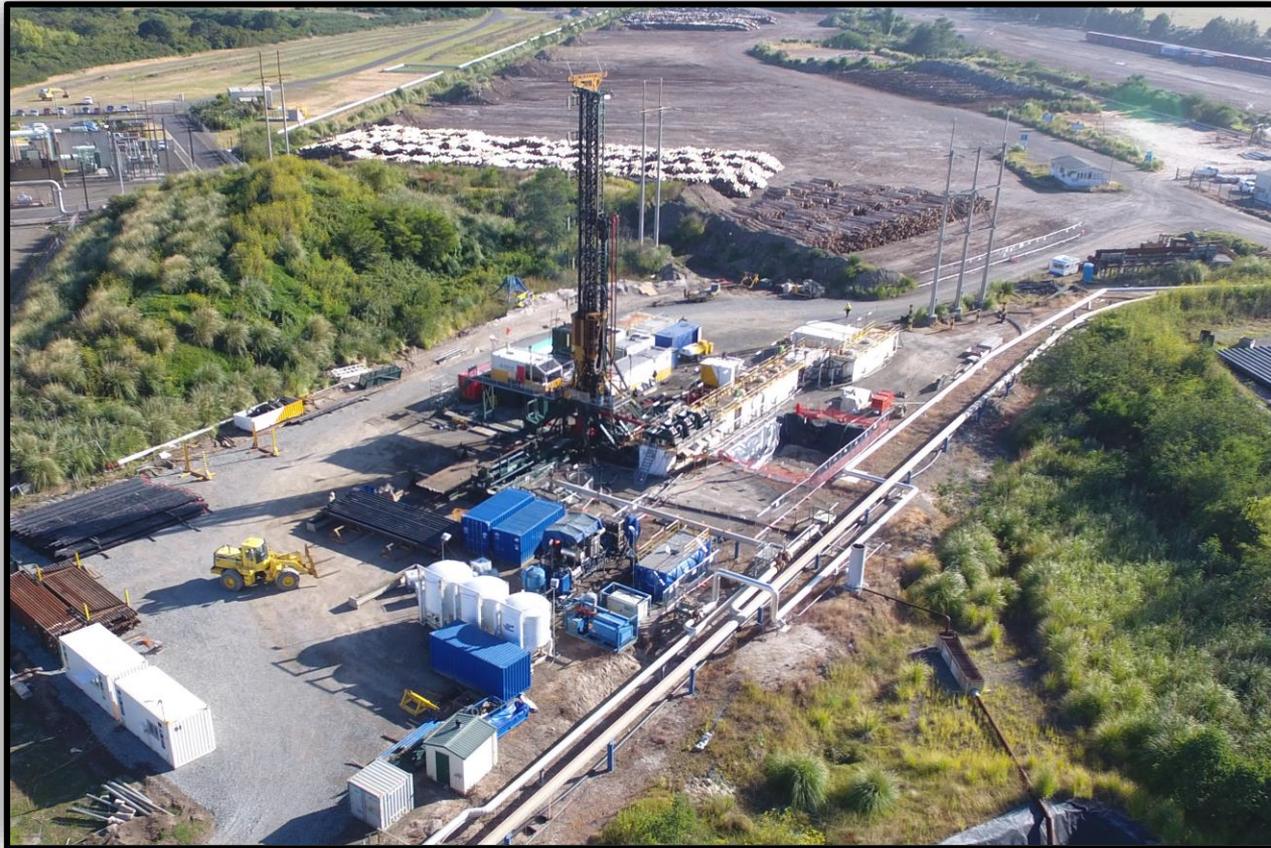
KA47 repair

Webster VR 500 Nova -1 Rig

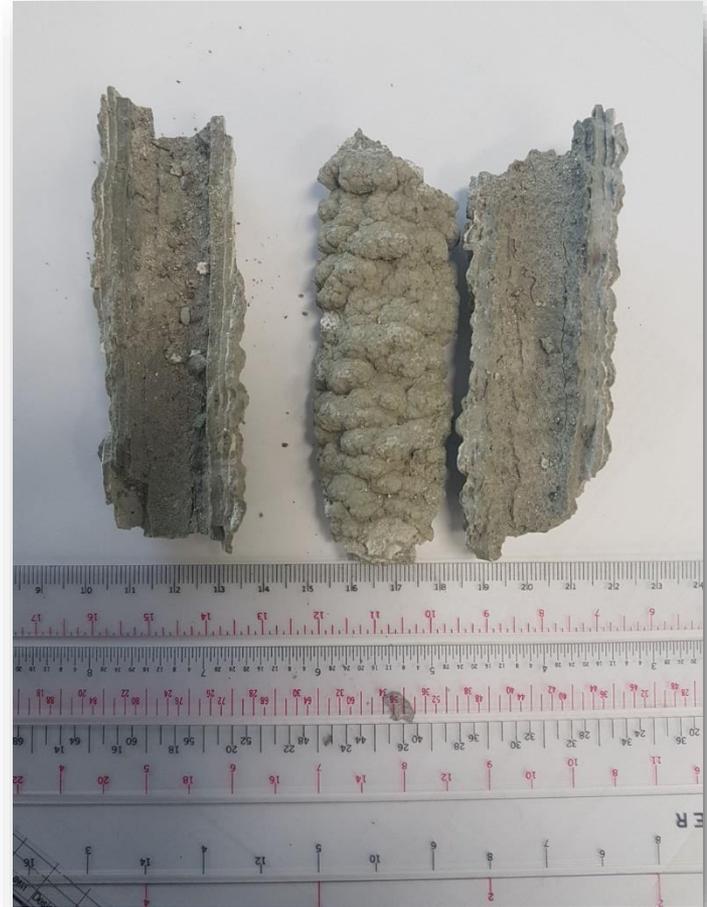
KA27 scale

30th June: Scale from KA27 Tube

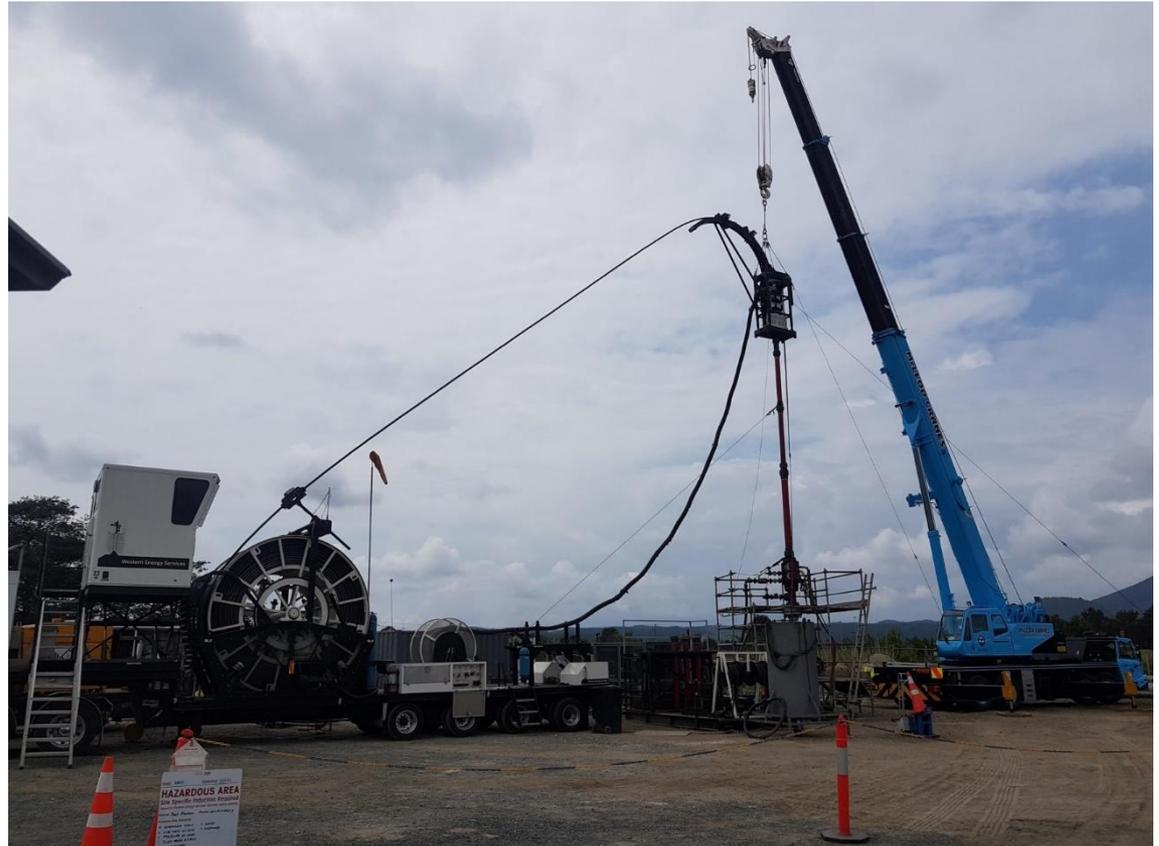
KA27 mechanical clean-out

Coiled Tubing Unit at work on KA27

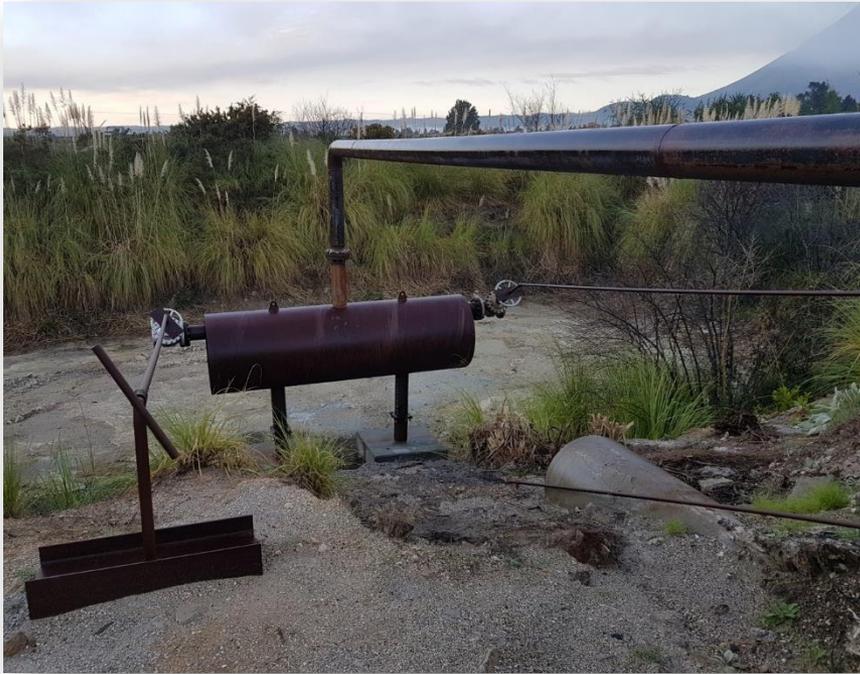
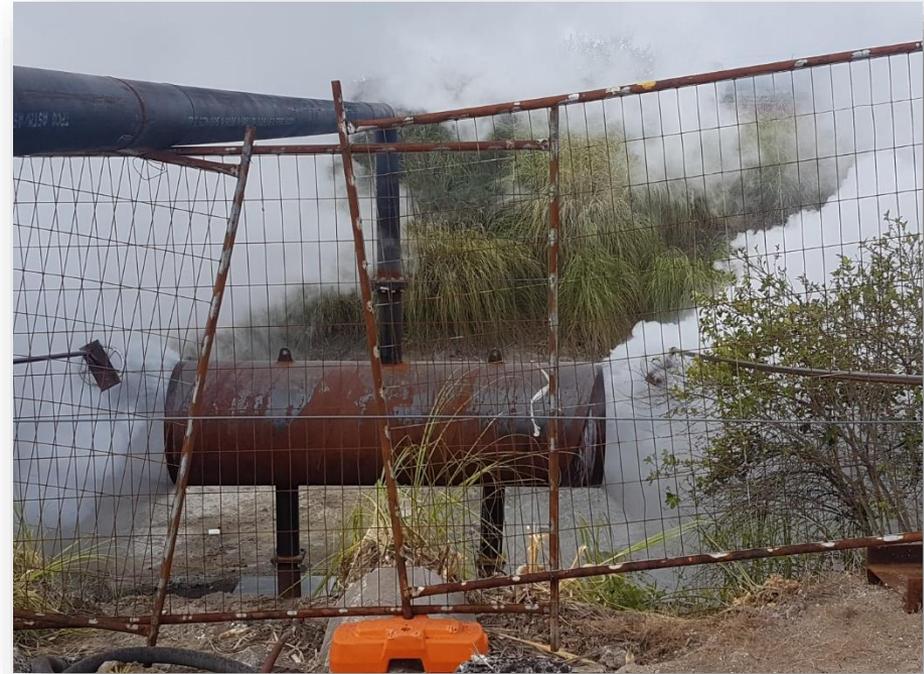
KA27 mechanical clean-out

NTGALs Silencer Arrangement
